TEMPERATURE AND PRESSURE PROFILES OBTAINED DURING BURN OF A SIDEWINDER MARK 17 MOD 5 MOTOR IN A 15,300 CUBIC-FOOT MAGAZINE

DL Technical Report No. TR-3139
September 1974

ABSTRACT

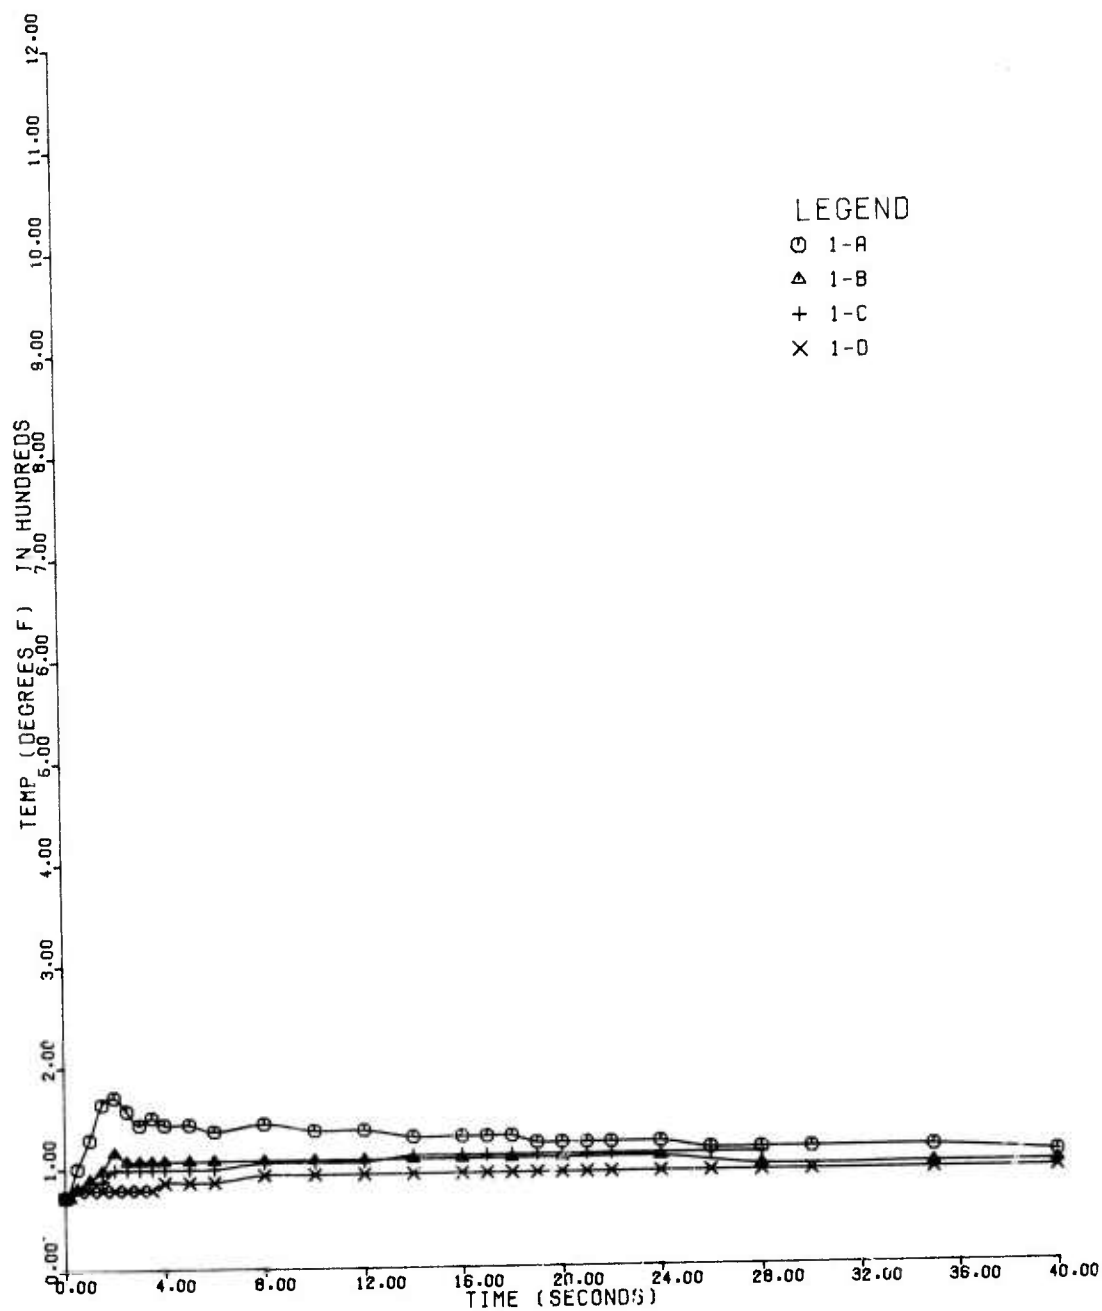
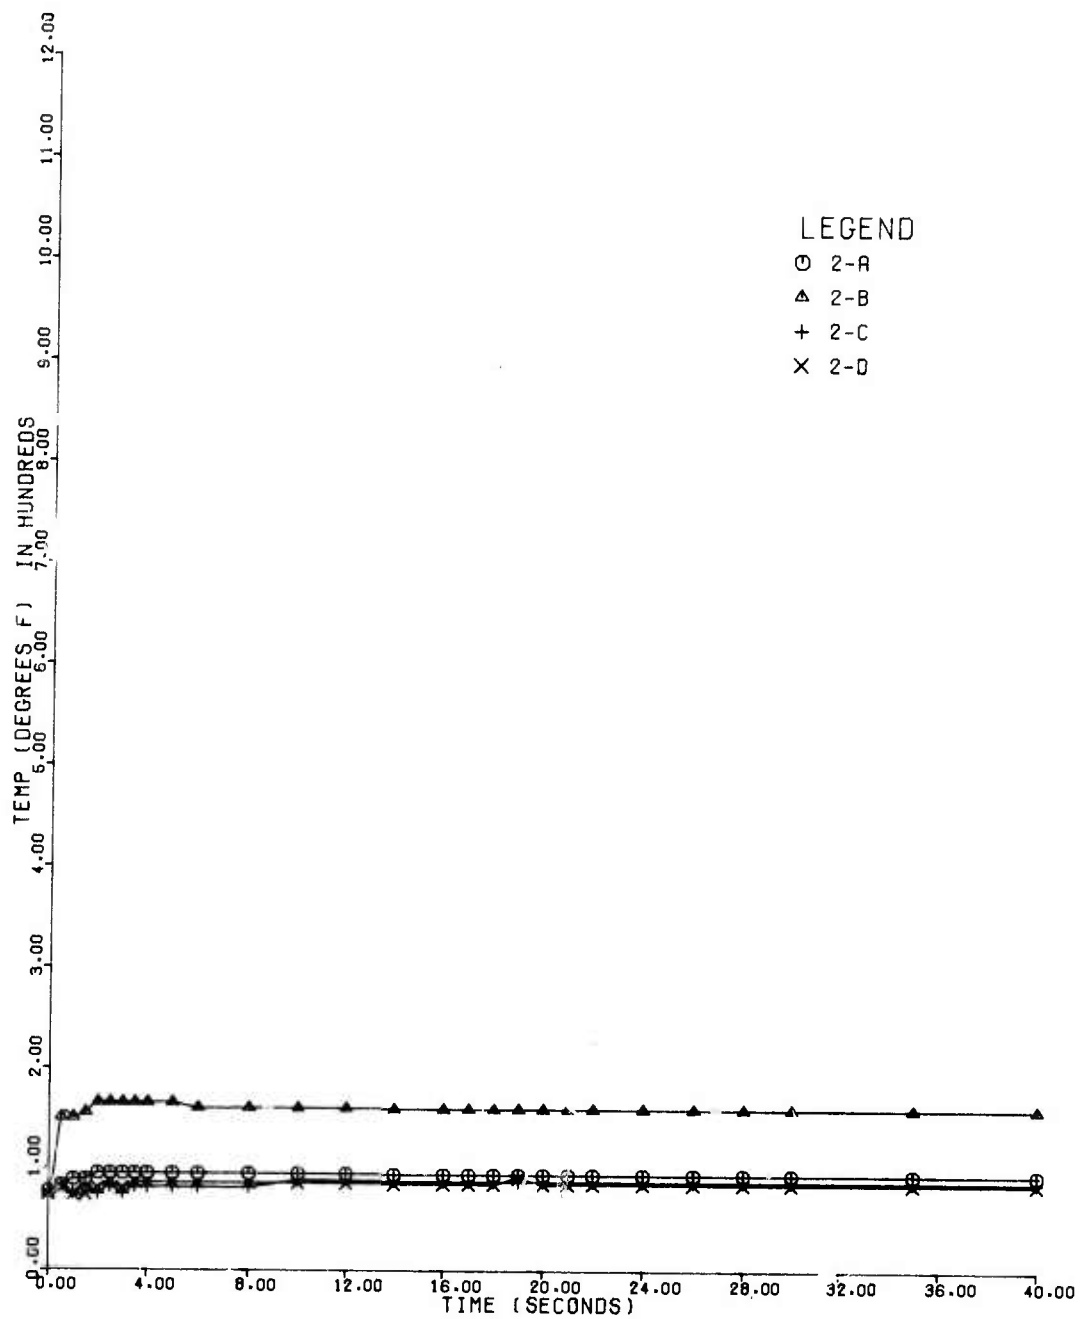
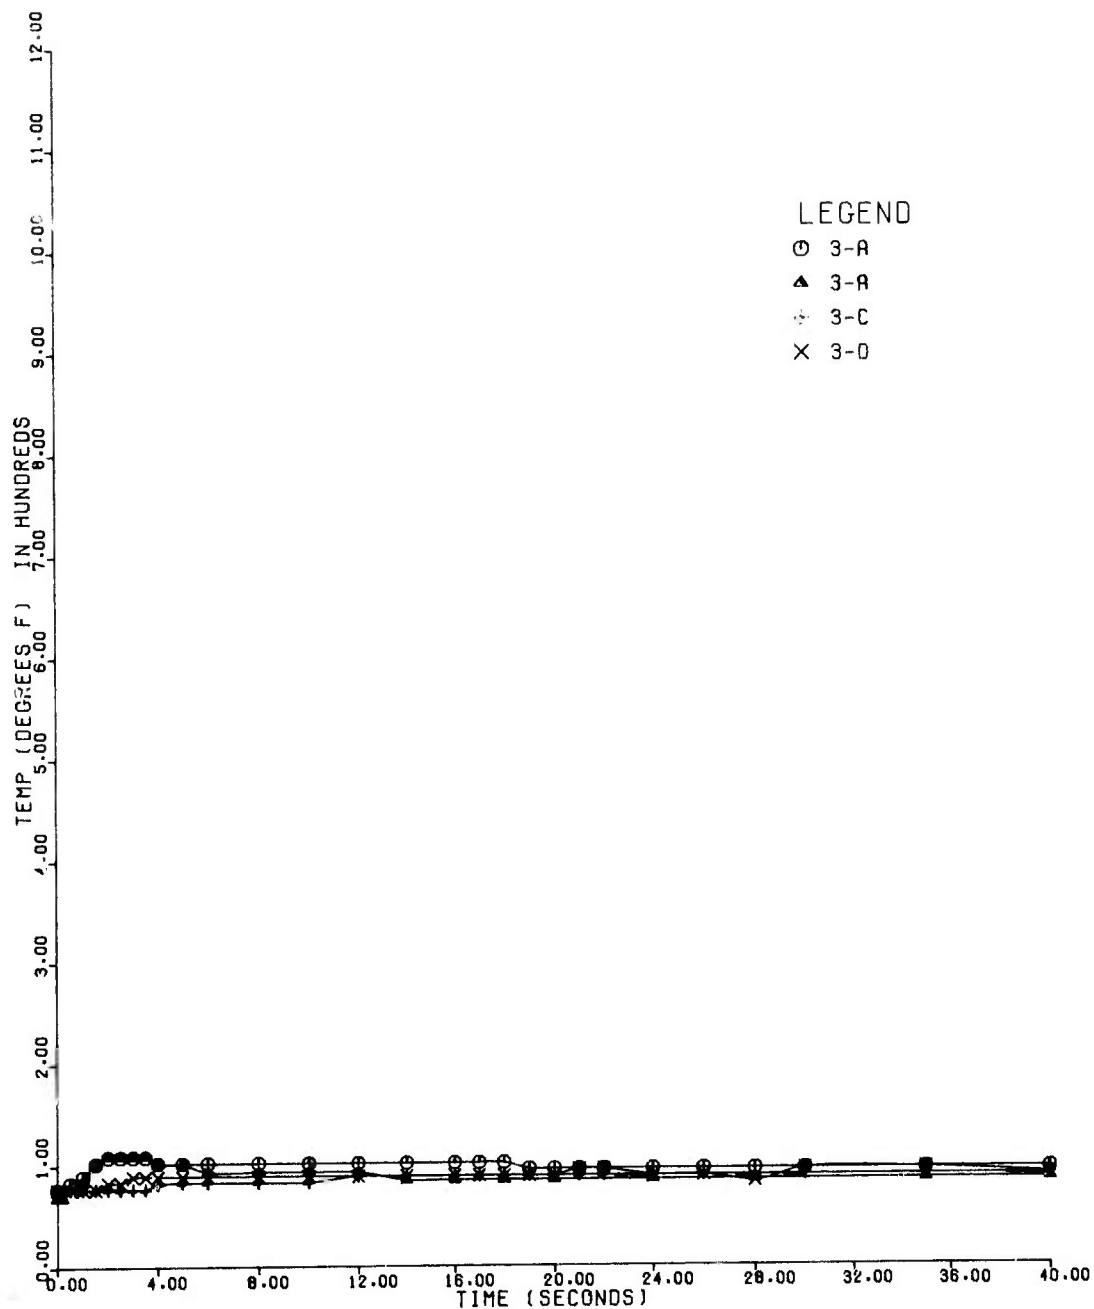
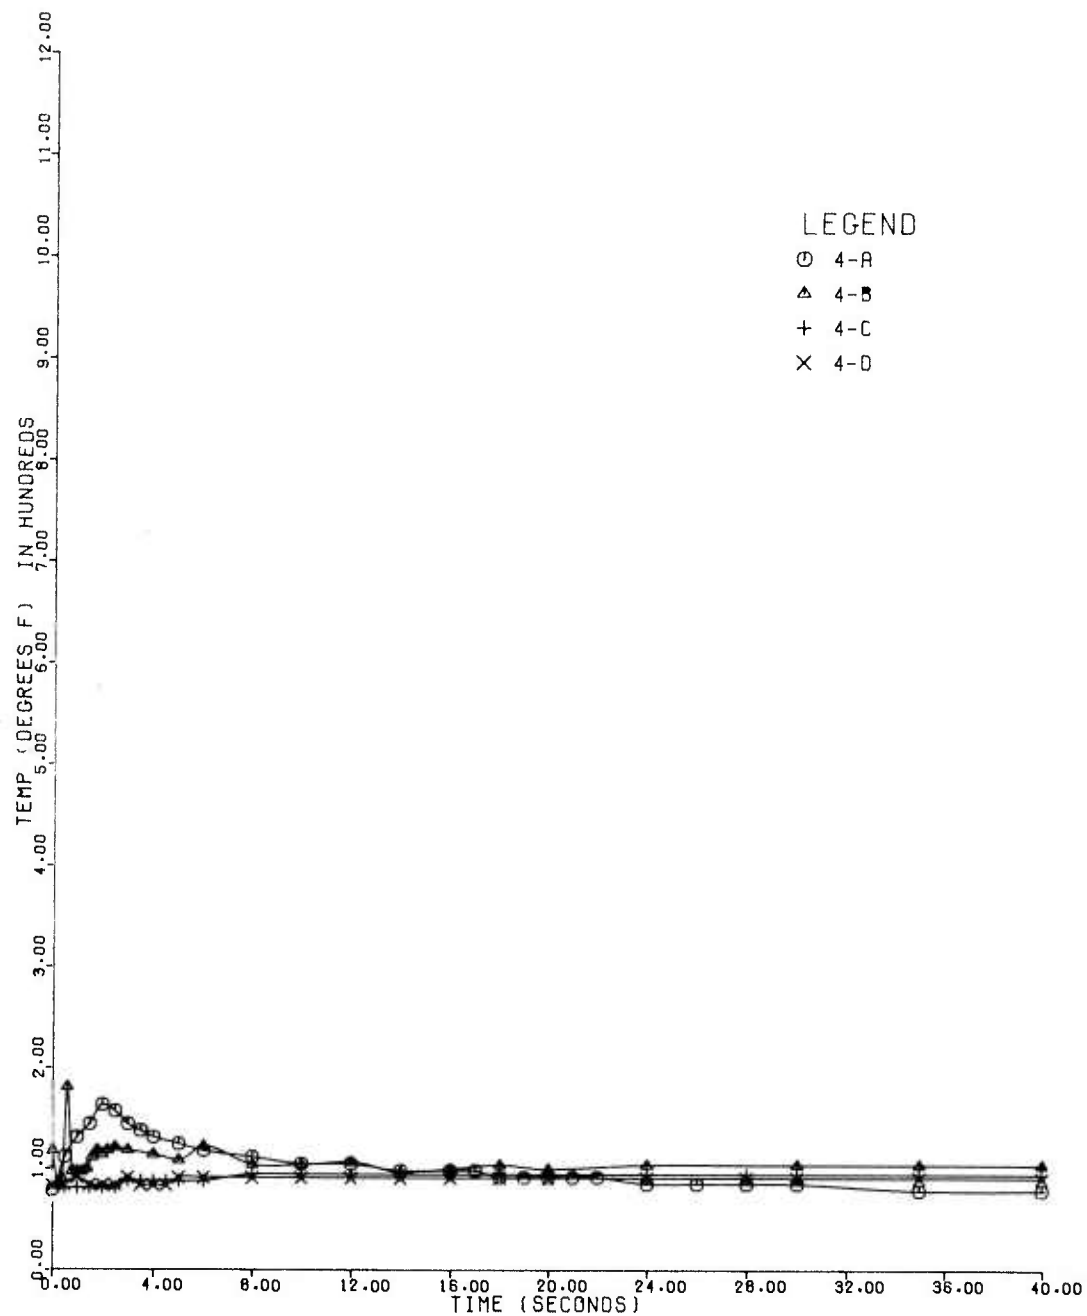
(4) Exterior and interior temperature measurements on the four inert, instrumented ZUNI motors located in the active motor exhaust plume are shown in Figures 28 through 31 of Appendix E.

2. Temperature data obtained for the inert, instrumented ZUNI motors (shown in Figures 28 through 31 of Appendix E) located in the 400°F isotherm of the exhaust plume of the active motor also indicate that the temperature was not severe enough to have caused cook-off had the motors been "live". However, ordnance cook-off may occur if there is direct long-term impingement of exhaust gases from an ignited motor.
